101 Fake road
Elmira, Ny 14901

Prepared by: Aber Inspection Services

General Information

Inspection Date: 05-26-22

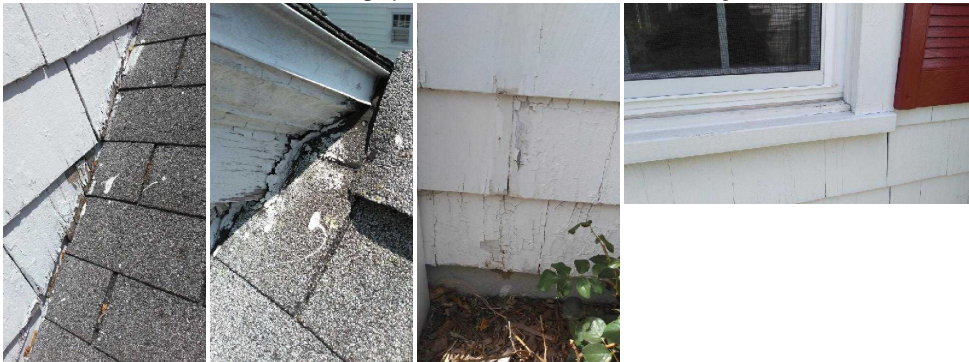
- 1. Type: Wood - minor paint peeling in a few spots and at window sills, siding contacting roof surface, recommend about one inch gap between to eliminate any future moisture damage.

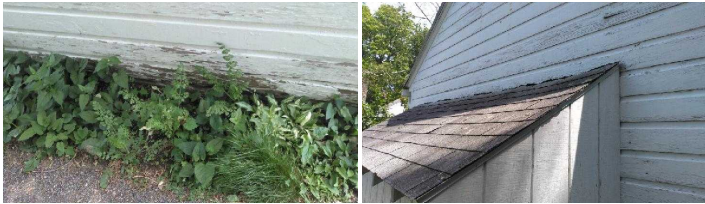
- 1. Type of Structure: Detached Car Spaces: 1
- 2. Garage Doors: Metal
- 3. Door Operation: Mechanized
- 4. Door Opener: Craftsman
- 5. Exterior Surface: Wood - Gaps not properly sealed at rear addition, Rot noted at bottom, recommend clearing vegetation away from siding

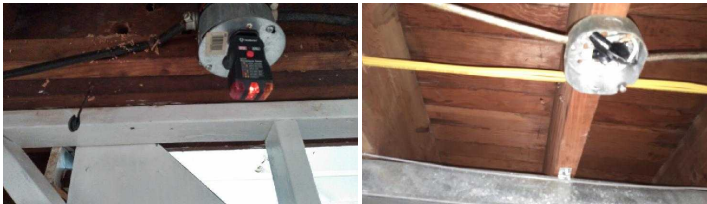
1. Unable to Inspect: 10%
2. Ceiling: Exposed framing
3. Walls: Concrete, Exposed framing
4. Floor: Poured
5. Floor Drain: capped off
6. Doors: wood
7. Windows: Wood casement
8. Electrical: 110 VAC outlets and lighting circuits - missing covers at junction boxes, exposed wires, Open ground at 3 prong outlets

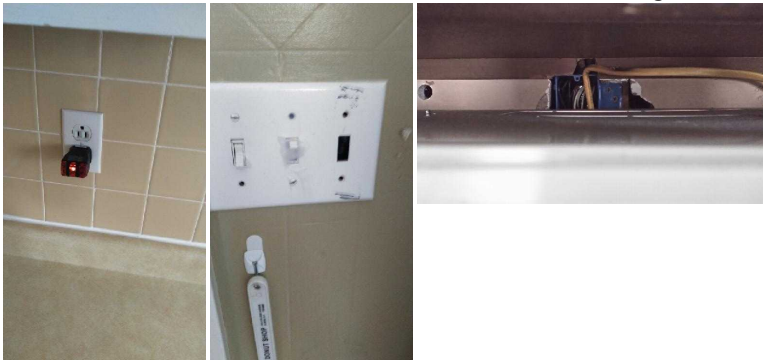
1. Cooking Appliances: Whirlpool
 2. Ventilator: Broan
 3. Disposal:
 4. Dishwasher: Kenmore
 5. Air Gap Present? Yes No
 6. Trash Compactor:
 7. Refrigerator: Frigidaire
 8. Microwave:
 9. Sink: Stainless Steel
 10. Electrical: 110 VAC outlets and lighting circuits - Open grounds noted at 3 prong outlets, Non-GFCI circuit -recommend GFCI circuit be installed, Missing outlet/switch cover plates

-electrical grounding. older home has been undated with three prong outlets on the first floor. all of these have open grounds which defeats the purpose of the three prong grounded outlet. Outlet near kitchen sink is recommended to have a GFCI outlet in today's standards, at the very least I recommend fixing the open ground situation. because of the age of the home these are not a requirement but well worth having an electrician evaluate.

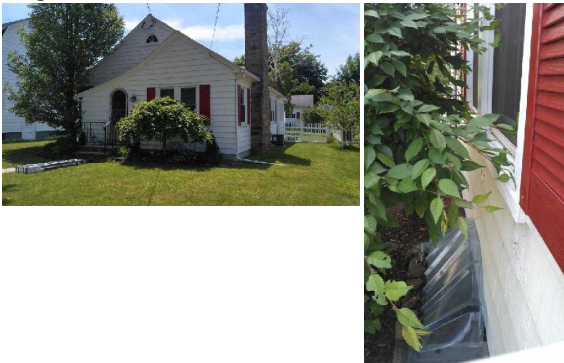
2. Vegetation: Shrubs, Trees - Tree limbs over hang the roof and should be cut back.

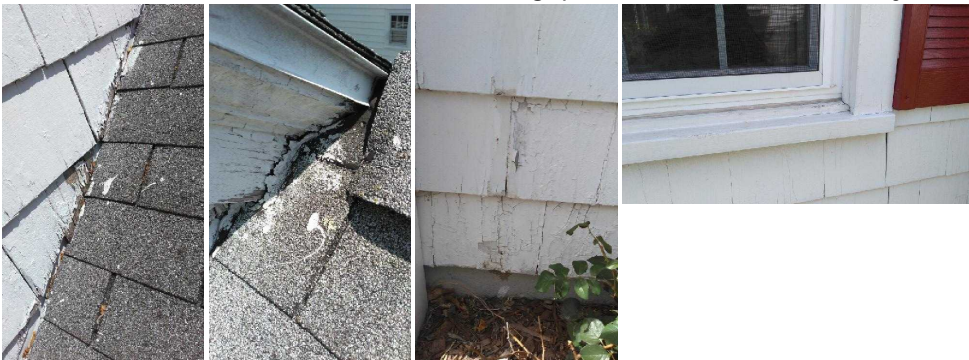
4. Facing West Exterior Surface Type: Wood - minor paint peeling in a few spots and at window sills, siding contacting roof surface, recommend about one inch gap between to eliminate any future moisture damage.

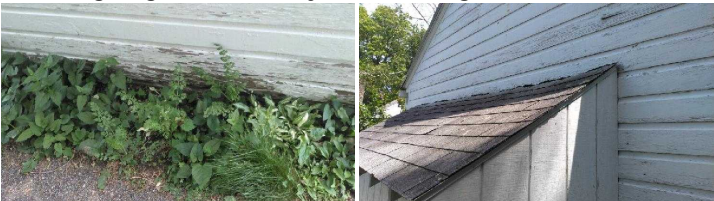
8. Rear Garage Exterior Surface: Wood - Gaps not properly sealed at rear addition, Rot noted at bottom, recommend clearing vegetation away from siding

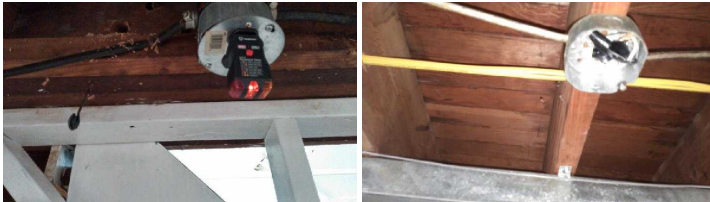
10. Basement Electrical: 110 VAC outlets and lighting circuits - missing covers at junction boxes, exposed wires, Open ground at 3 prong outlets

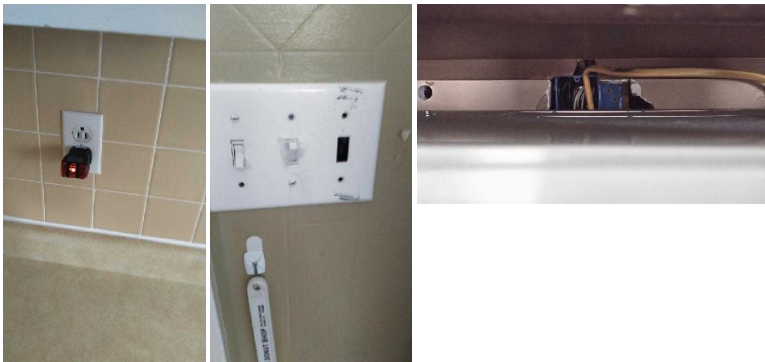
14. 1st Floor Kitchen Electrical: 110 VAC outlets and lighting circuits - Open grounds noted at 3 prong outlets, Non-GFCI circuit - recommend GFCI circuit be installed, Missing outlet/switch cover plates
