101 Fake road
Elmira, Ny 14901

Prepared by: Aber Inspection Services

General Information

Inspection Date: 05-26-22

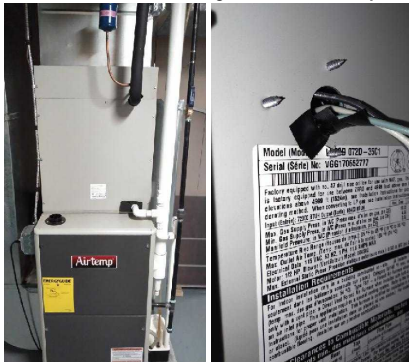
Basement Heating System

1. Heating System Operation: Adequate
2. Manufacturer: Crysler-Airtemp

3. Model Number: 072d-35c1 Serial Number: VGG170652777
4. Type: Forced air Capacity: 72k btu
5. Area Served: Whole building Approximate Age: 5 years
6. Fuel Type: Natural gas
7. Heat Exchanger: 4 Burner

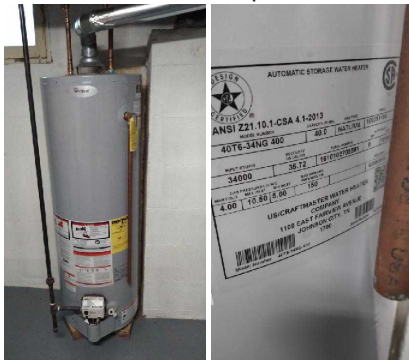
Basement Water Heater

- 8. Water Heater Operation: Functional at time of inspection
- 9. Manufacturer: whirlpool

10. Model Number: 40T6-34NG 400 Serial Number: 1610102705581
